APPLICATION NOTE NO. 75

Maintenance of SBE 5T and 5M Pumps

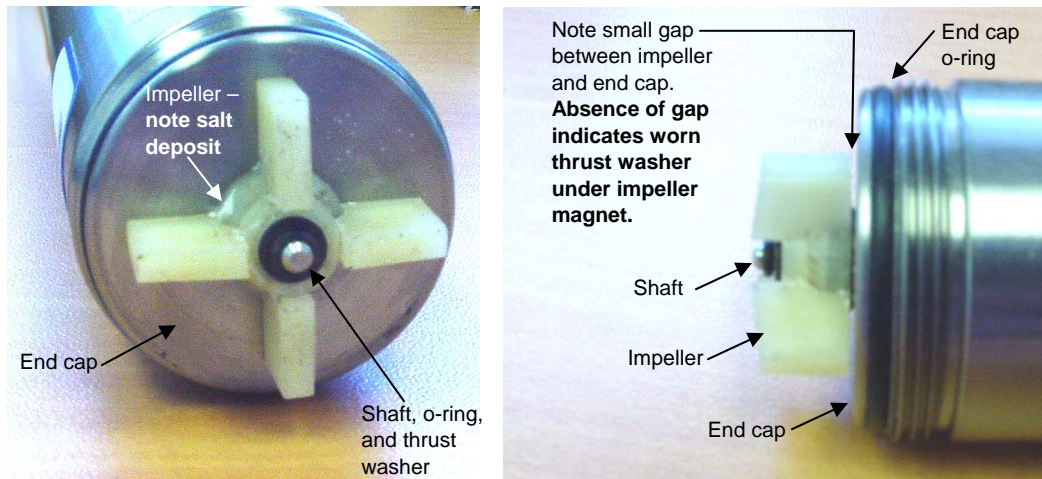
SBE 5T with Pump Head Removed

1. Unscrew the pump head from the housing.
2. Using clean, fresh water, thoroughly rinse the pump head and impeller.
3. Inspect the impeller for salt deposits. Clean any deposits with clean, fresh water and a toothbrush. Verify that the impeller can turn freely.
4. Inspect the shaft, and the o-ring and thrust washer holding the impeller on the shaft. There is another thrust washer underneath the impeller magnet, inside the housing. If this thrust washer is in good condition, you should observe a small gap between the bottom of the impeller and the end cap. If there is no gap, the thrust washer is worn and needs to be replaced (see *Yearly Maintenance for SBE 5T* for replacement procedure).

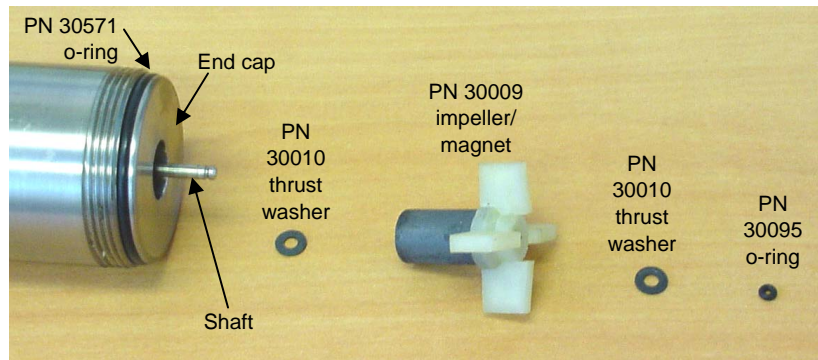
SBE 5T with Pump Head and Impeller Removed

- B. Pull the impeller and attached magnet off the shaft. The thrust washer above the impeller will come off at the same time. Inspect the impeller for salt build-up, and clean if necessary. Inspect the magnet for wear. Particularly in sandy coastal environments, the magnet may be worn down from abrasion. If necessary, replace the impeller / magnet assembly (PN 30009).

- C. Remove the second thrust washer from the bottom of the shaft. A pair of tweezers works well for this.
 - D. Inspect the shaft for wear.
 - E. Rinse the shaft and depression in the housing with clean, fresh water. Allow to dry.

- F. Using new thrust washers (2 of PN 30010) and o-ring (PN 30095), replace the thrust washer and impeller / magnet on the shaft. Replace the other thrust washer and o-ring on the shaft, above the impeller, pushing hard with your fingertip to seat the thrust washer and o-ring in place.

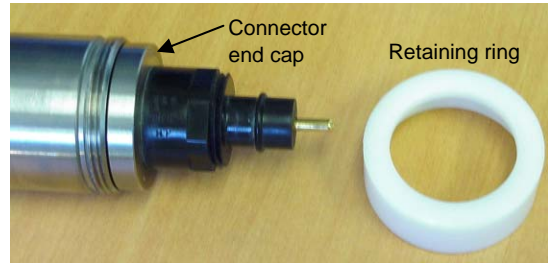
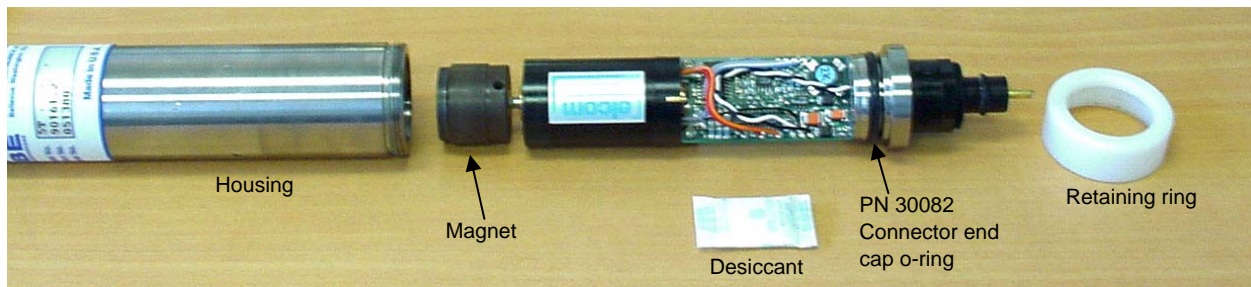
1. Unscrew the connector end cap retaining ring. Pull out the end cap and attached electronics from the housing.
2. Verify that the magnet can spin freely and is not broken or damaged.

3. Look for other signs of damage on the electronics.
4. Inspect the connector end cap o-ring and the mating surface in the housing for dirt, nicks, and cuts. Clean as necessary. If the o-ring or mating surface is damaged, return the pump to Sea-Bird for repairs.

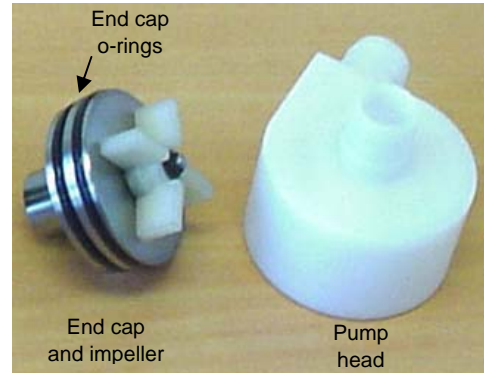
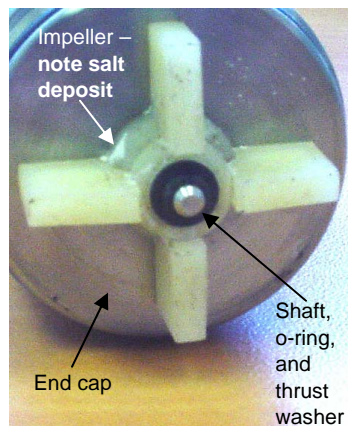
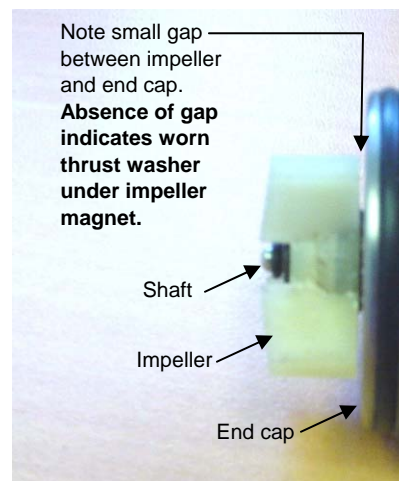
SBE 5M with Pump Head Removed

1. Unscrew the pump head from the housing.
2. Pull out the end cap from the housing.
3. Using clean, fresh water, thoroughly rinse the pump head and impeller.

4. Inspect the impeller for salt deposits. Clean any deposits with clean, fresh water and a toothbrush. Verify that the impeller can turn freely.
5. Inspect the shaft, and the o-ring and thrust washer holding the impeller on the shaft. There is another thrust washer underneath the impeller magnet, inside the housing. If this thrust washer is in good condition, you should observe a small gap between the bottom of the impeller and the end cap. If there is no gap, the thrust washer is worn and needs to be replaced (see *Yearly Maintenance for SBE 5M* for replacement procedure).

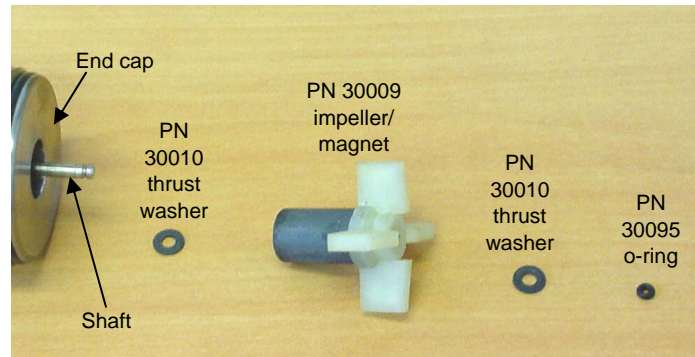
SBE 5M with Pump Head and Impeller Removed

3. Replace the o-ring and 2 thrust washers on the shaft:
 - A. Remove the o-ring from the shaft. A pair of tweezers works well for this.
 - B. Pull the impeller and attached magnet off the shaft. The thrust washer above the impeller will come off at the same time. Inspect the impeller for salt build-up, and clean if necessary. Inspect the magnet for wear. Particularly in sandy coastal environments, the magnet may be worn down from abrasion. If necessary, replace the impeller / magnet assembly (PN 30009).

- C. Remove the second thrust washer from the bottom of the shaft. A pair of tweezers works well for this.
 - D. Inspect the shaft for wear.
 - E. Rinse the shaft and depression in the housing with clean, fresh water. Allow to dry.

- F. Using new thrust washers (2 of PN 30010) and o-ring (PN 30095), replace the thrust washer and impeller / magnet on the shaft. Replace the other thrust washer and o-ring on the shaft, above the impeller, pushing hard with your fingertip to seat the thrust washer and o-ring in place.

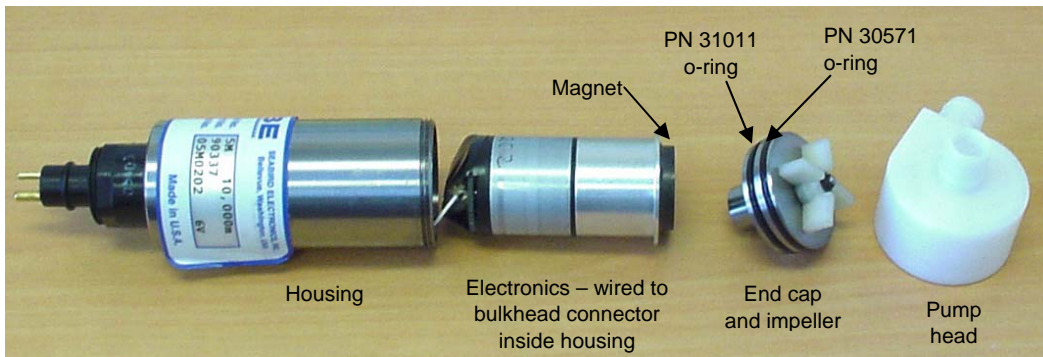
1. Unscrew the pump head from the housing.
2. Pull out the end cap from the housing.
3. Pull out the electronics from the housing. Note that the electronics are wired to the bulkhead connector inside the housing.
4. Verify that the magnet can spin freely and is not broken or damaged.
5. Look for other signs of damage.
6. Apply a light coat of o-ring lubricant (Parker Super O Lube) to the o-ring and mating surfaces. Reinstall the electronics in the housing. Reinstall the end cap in the housing, carefully aligning the end cap with the housing and pushing hard on the end cap to seat the first o-ring in the housing (only 1 o-ring should now be visible).
CAUTION: If you are not careful, you may *pinch* the o-ring, which may allow water to enter the housing, damaging the electronics.
7. Reinstall the pump head on the end cap.
